THE SECRETARY
OF THE INTERIOR'S
STANDARDS FOR
THE TREATMENT
OF HISTORIC
PROPERTIES

GUIDELINES FOR PRESERVING, REHABILITATING, RESTORING & RECONSTRUCTING HISTORIC BUILDINGS

Revised by Anne E. Grimmer

> U.S. Department of the Interior National Park Service Technical Preservation Services Washington, D.C.

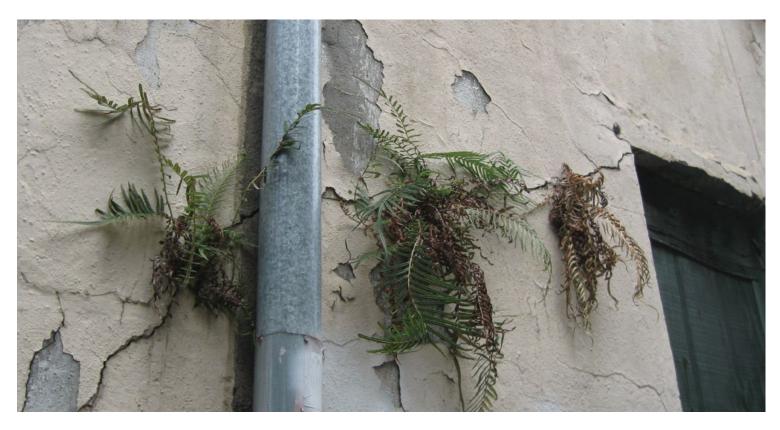
[3] **Not Recommended:** Cracks in the stucco have not been repaired, thereby allowing ferns to grow in the moist substrate which will cause further damage to the masonry.

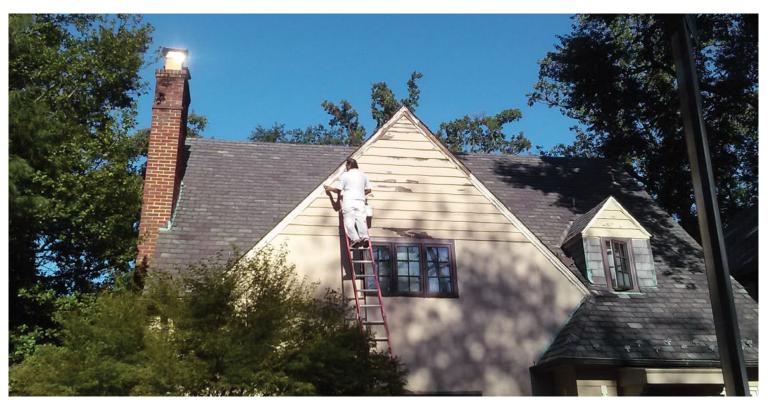
[4] Hand scraping to remove peeling paint from wood siding in preparation for repainting is an important part of regularly-scheduled maintenance.

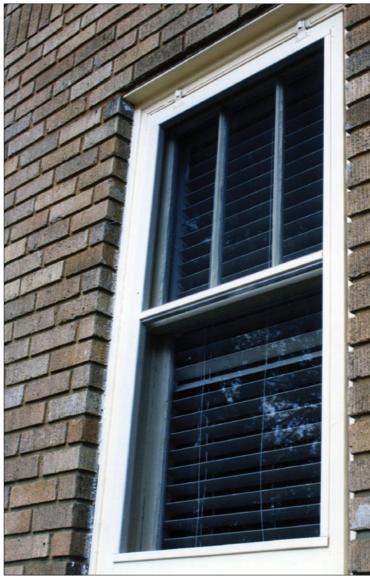
[10] Historic exterior storm windows preserve and help to insulate wood windows.

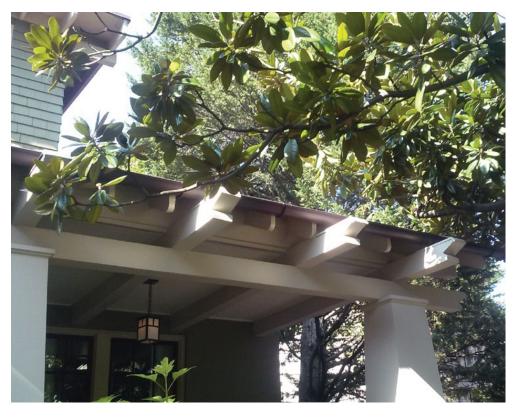
[12] Repair and limited replacement in kind to match deteriorated wood porch features is always a recommended preservation treatment.

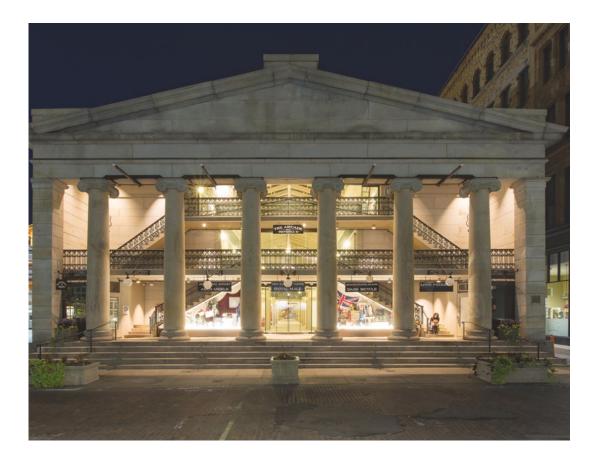
[1] An alkaline-based product is appropriate to use to clean historic marble because it will not damage the marble, which is acid sensitive.

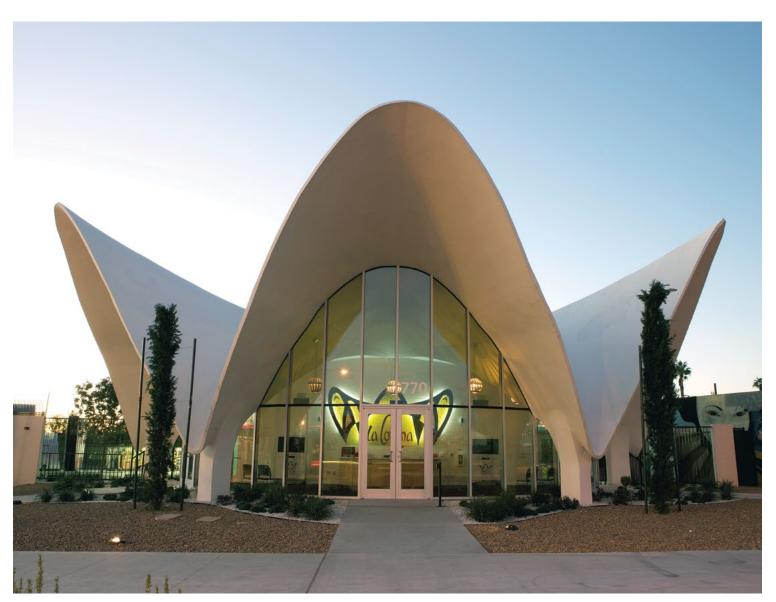
[2] Mid-century modern building technology made possible the form of this parabolashaped structure and its thin concrete shell construction. Built in 1961 as the lobby of the La Concha Motel in Las Vegas, it was designed by Paul Revere Williams, one of the first prominent African-American architects. It was moved to a new location and rehabilitated to serve as the Neon Museum, and is often cited as an example of Googie architecture. Credit: Photographed with permission at The Neon Museum, Las Vegas, Nevada.

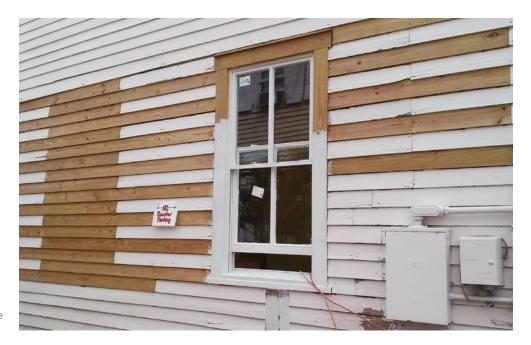
[8] Rotted clapboards have been replaced selectively with new wood siding to match the originals.

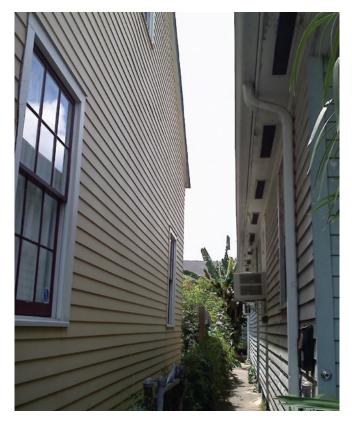
[9] Smooth-surfaced cementitious siding (left) may be used to replace deteriorated wood siding only on secondary elevations that have minimal visibility.

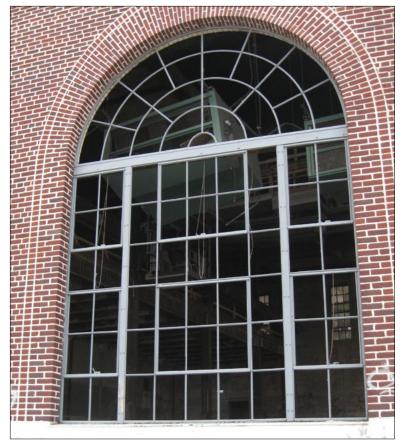
[12] This historic steel window has been cleaned, repaired, and primed in preparation for painting and reglazing.

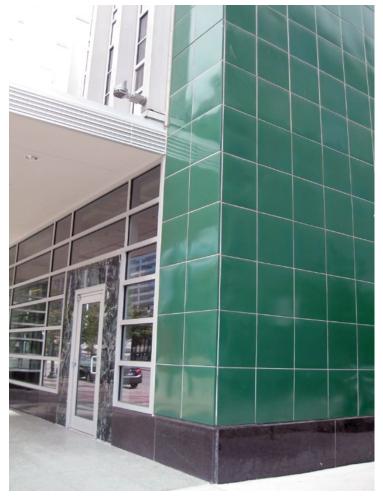
[15] New enameled-metal panels were replicated to replace the original panels, which were too deteriorated to repair, when the storefront of this early 1950s building was recreated.

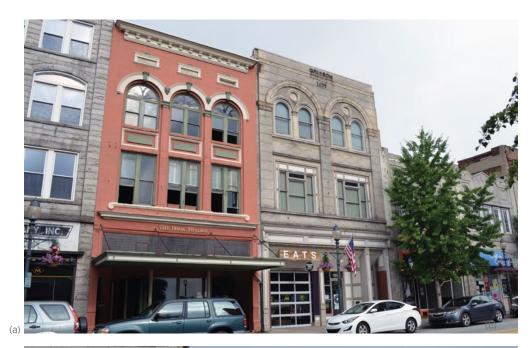
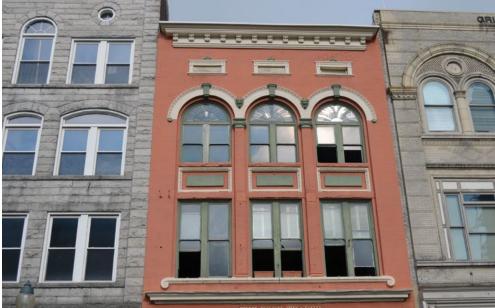
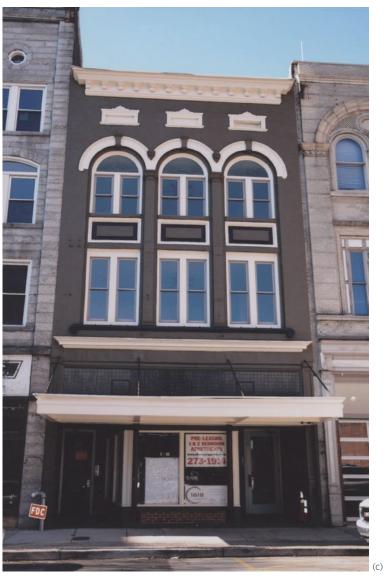
[22] **Not Recommended:** (a-b) The original wood windows in this late-19th-century building, which were highly decorative, could likely have been repaired and retained. (c) Instead, they were replaced with new windows that do not match the detailing of the historic windows and, therefore, do not meet the Standards (above).

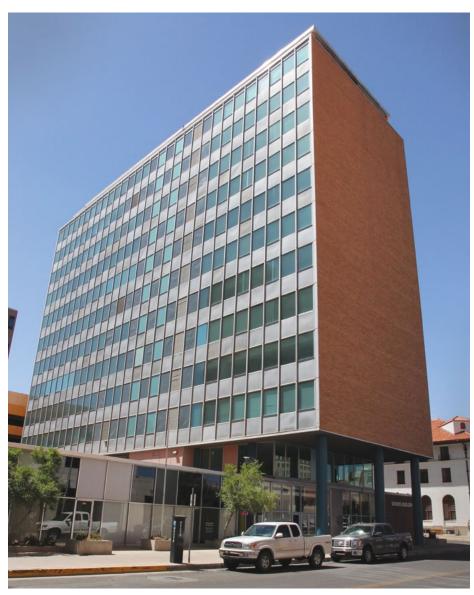
[30] Rather than replace the original curtain wall system of the 1954 Simms Building in Albuquerque, NM, with a different color tinted glass or coat it with a non-historic reflective film, the HVAC system was updated to improve energy efficiency. *Photo: Harvey M. Kaplan.*

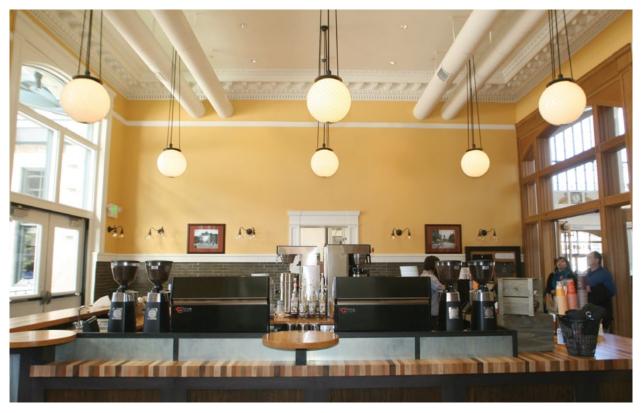
[37] Exposed and painted ducts were appropriately installed here in a retail space in Denver's historic Union Station after considering other options that would have impacted the ceiling height, or damaged or obscured the ornamental plaster crown molding. Photo: Heritage Consulting Group.

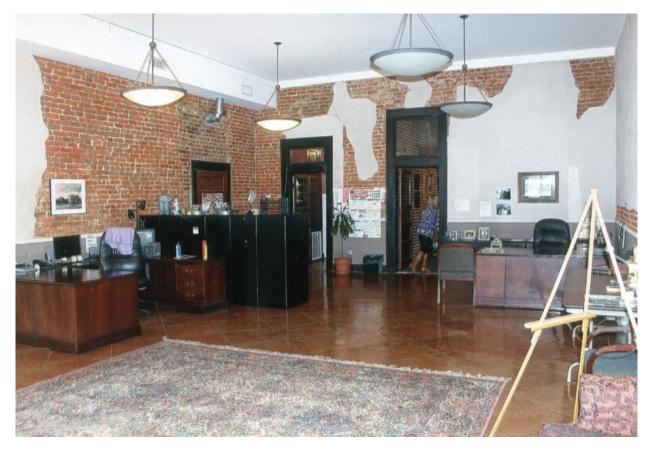
[41] Not Recommended: Leaving fragments of deteriorated or "sculpted" plaster is not a compatible treatment for either finished or unfinished interior spaces.

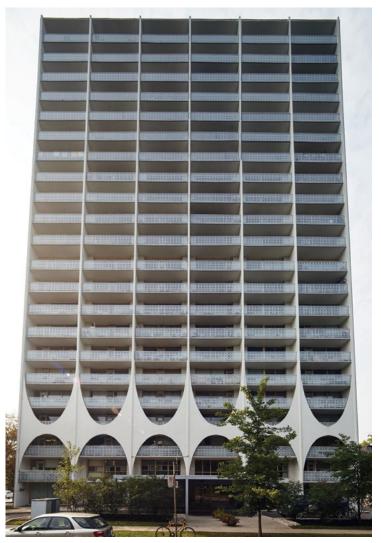
[59] (a-b) The decorative concrete balcony railings on this 1960s building did not meet life-safety code requirements. They were replaced with new glass railings with a fritted glass pattern matching the original design—a creative solution that satisfies codes, while preserving the historic appearance of the building when viewed from the street (c-d). Photos: (a, b, d) ERA Architects, Inc.; (c) Nathan Cyprys, photographer.

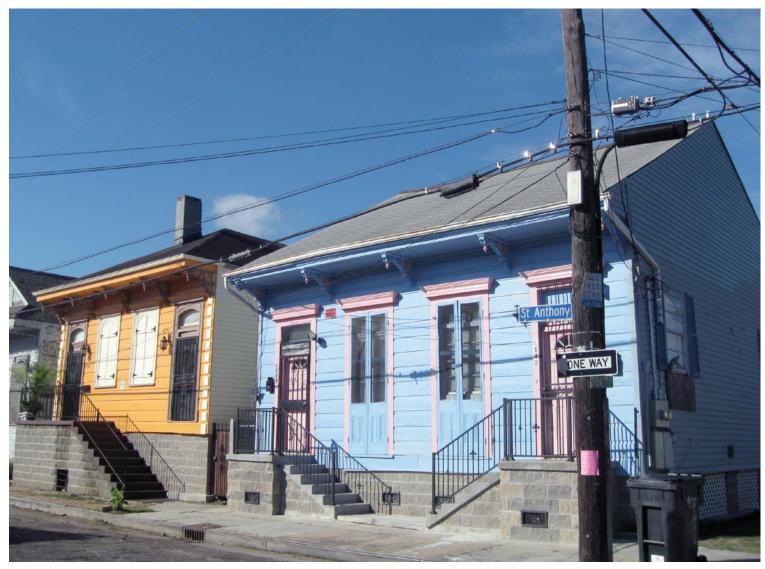
[60] In some instances, it may be necessary to elevate a historic building located in a floodplain to protect it. But this treatment is appropriate only if elevating the building will retain its historic character, including its relationship to the site, and its new height will be compatible with surrounding buildings if in a historic district. The house on the right, which has been raised only slightly, has retained its historic character. The house on the left has been raised several feet higher, resulting in a greater impact on the historic character of the house and the district.

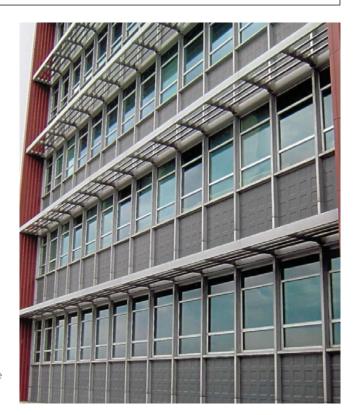
[12] This historic curtain wall features a distinctive variety of panel types which must be repaired or replicated in a restoration project if any are damaged or missing.

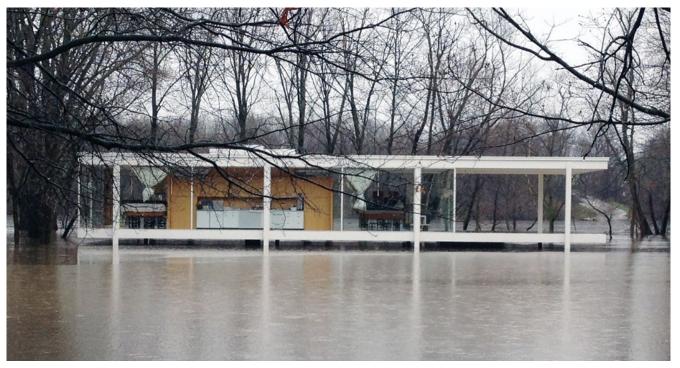
[19] The 1951 Mies van der Rohe-designed Farnsworth House, Plano, IL, was built close to the Fox River, which is increasingly prone to floods. To preserve the house in its original location, historic preservation architects and engineers continue to explore ways to protect it from the flooding, including a possible system that would lift the house above the flood waters and lower it back to the ground. Photo: Courtesy Farnsworth, A Site of the National Trust for Historic Preservation.
